TYPE 1 RECONNAISSANCE LEVEL CHARACTERIZATION REPORT (RLCR)

BUILDING T707B CLOSURE PROJECT

REVISION 0

July 14, 2004

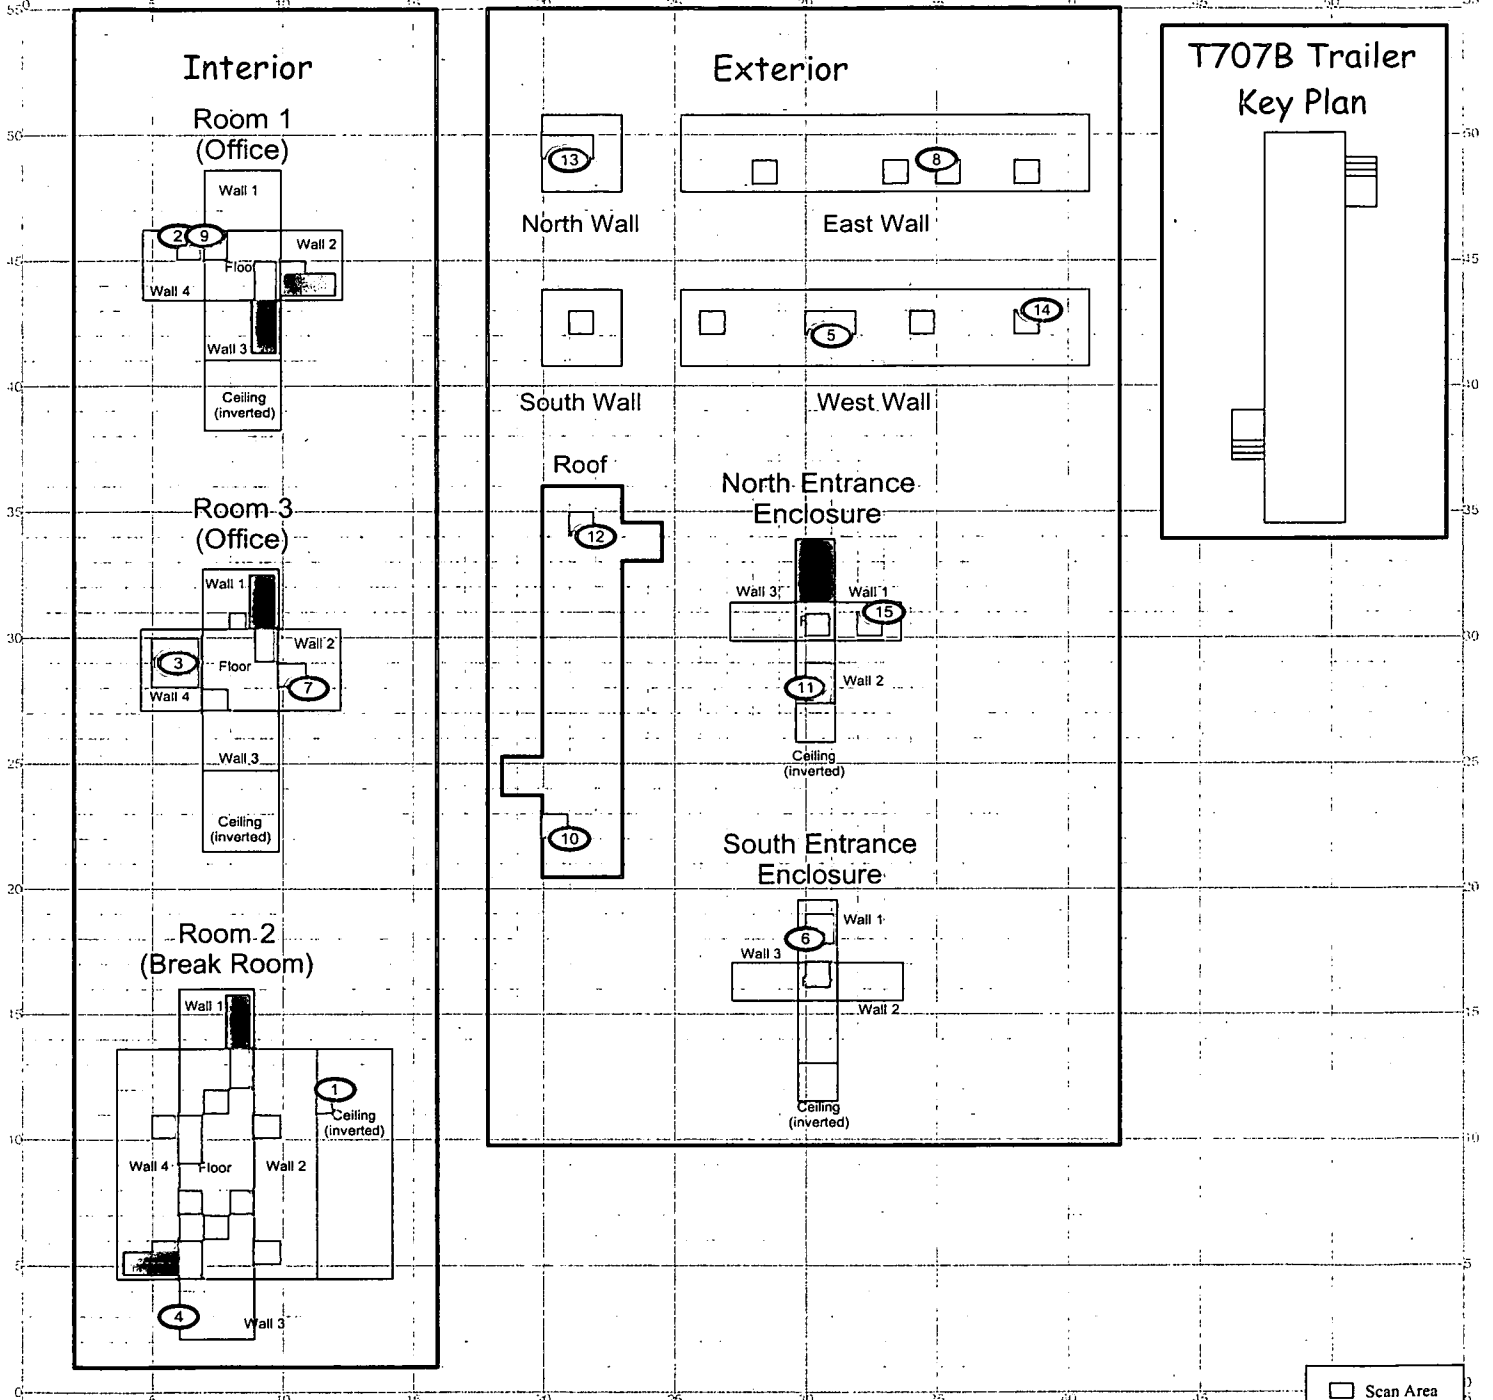
PRE-DEMOLITION SURVEY FOR T707B

Survey Area: 2 Survey Unit: T707B1 Classification: 3
 Building: T707B
 Survey Unit Description: Building T707B Interior & Exterior
 Total Area: 403 sq. m. Total Floor Area: 46 sq. m.

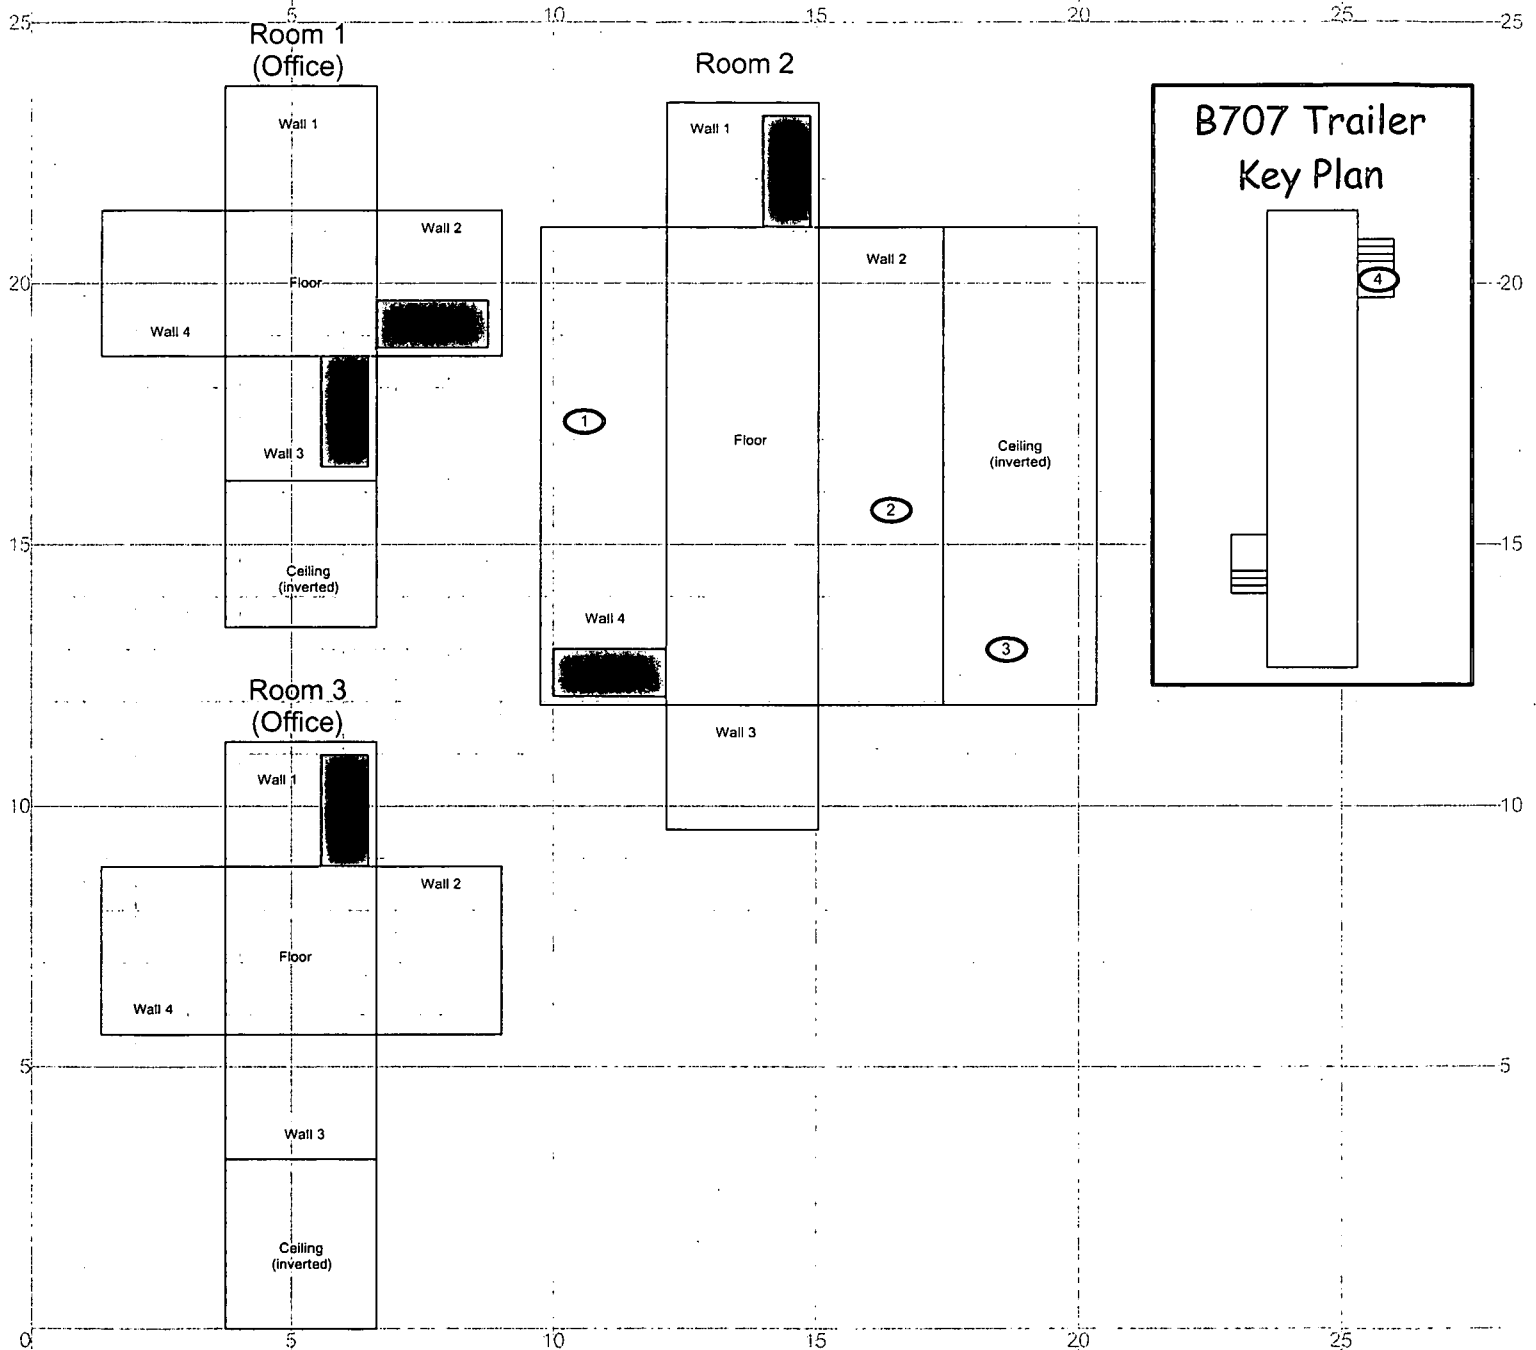
Building T707B
Asbestos

A comprehensive, invasive asbestos inspection was conducted to determine the presence of friable and non-friable asbestos containing building materials. Four samples were taken and all results were "Non Detect". The trailer has a sheet metal roof that covers a layer of fibrous glass insulation. Asbestos laboratory sample data and location maps are contained in Attachment D, *Chemical Data Summaries and Sample Maps*.

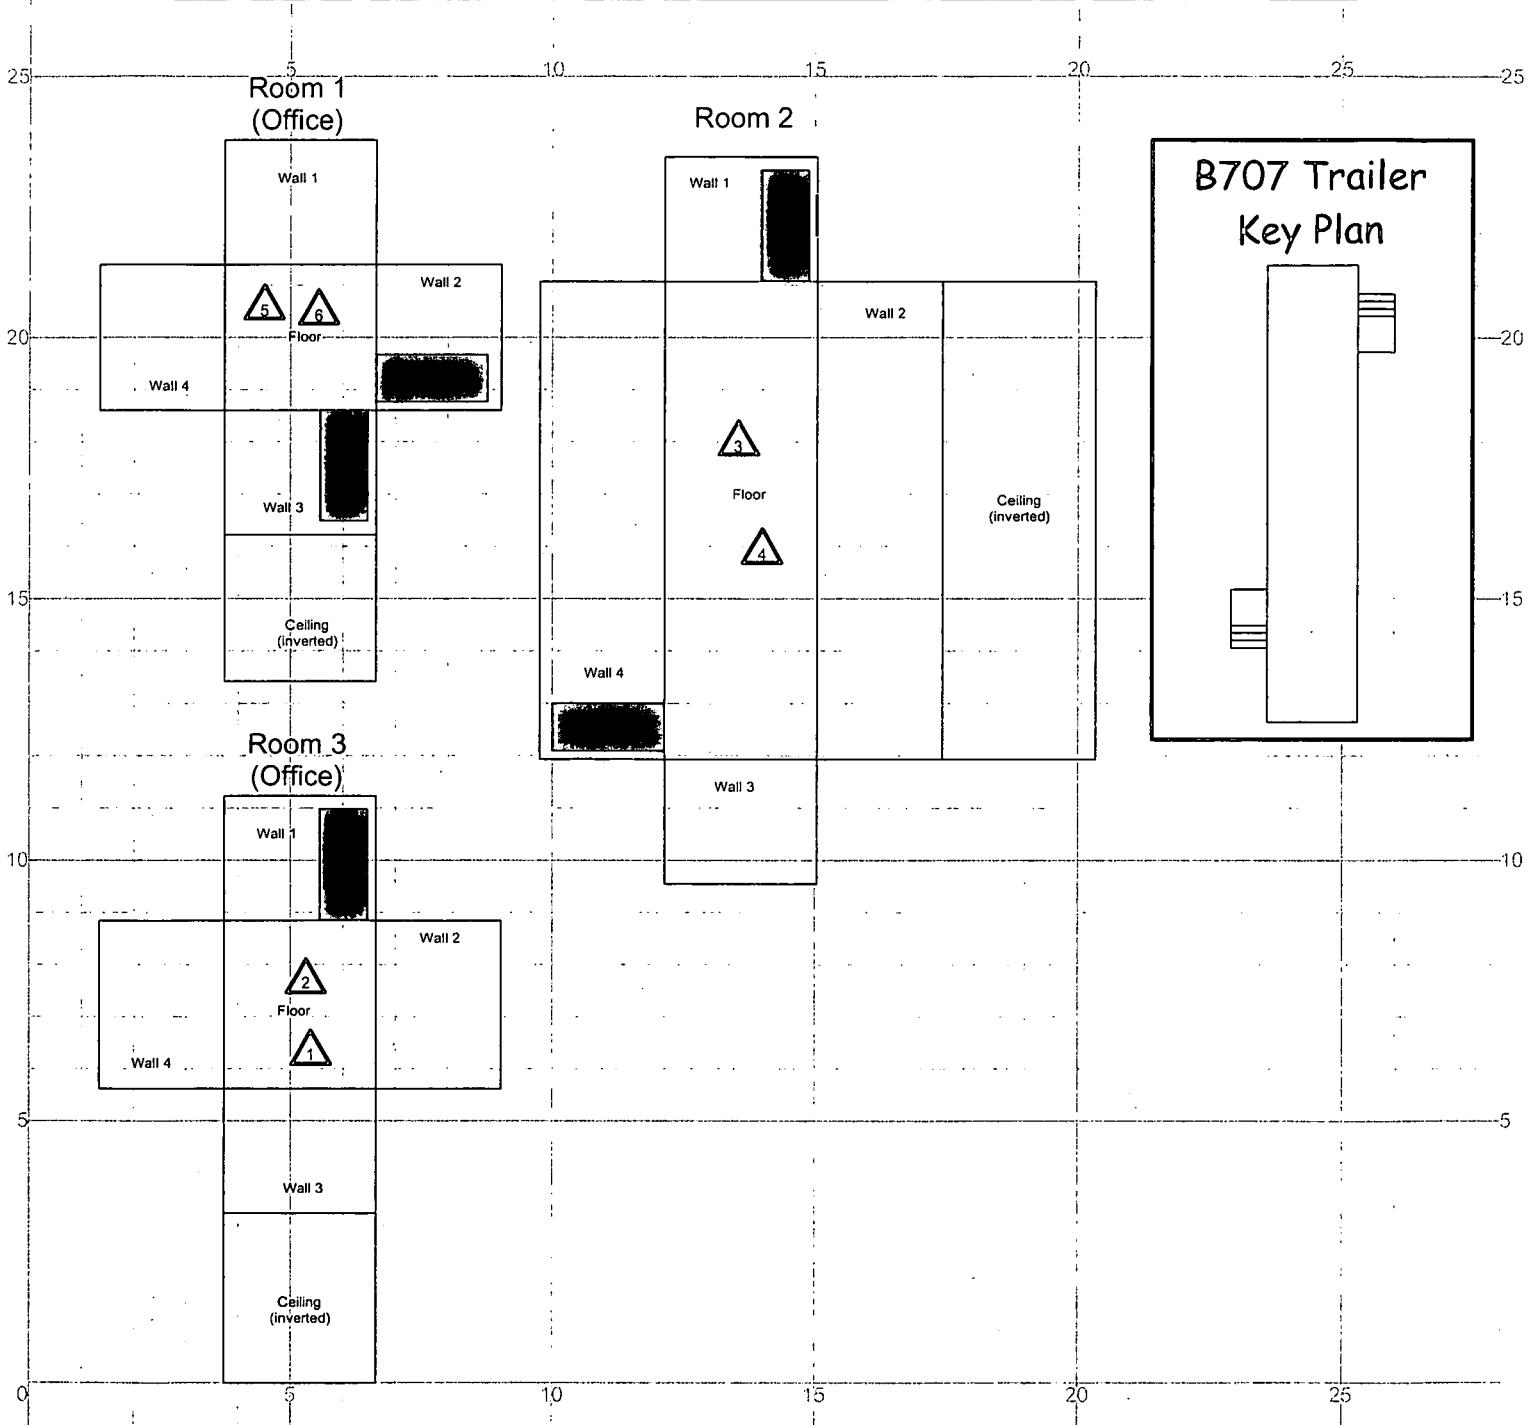
Building T707B
Beryllium

Six (6) biased beryllium smear samples were taken and all results were less than 0.1 $\mu\text{g}/100\text{cm}^2$ and meet the unrestricted release limits. Beryllium laboratory sample data and location maps are contained in Attachment D, Chemical Data Summaries and Sample Maps.
